**Figure A-23**  
**Water-Level Elevations in USGS Meadowbrook Park Wells**

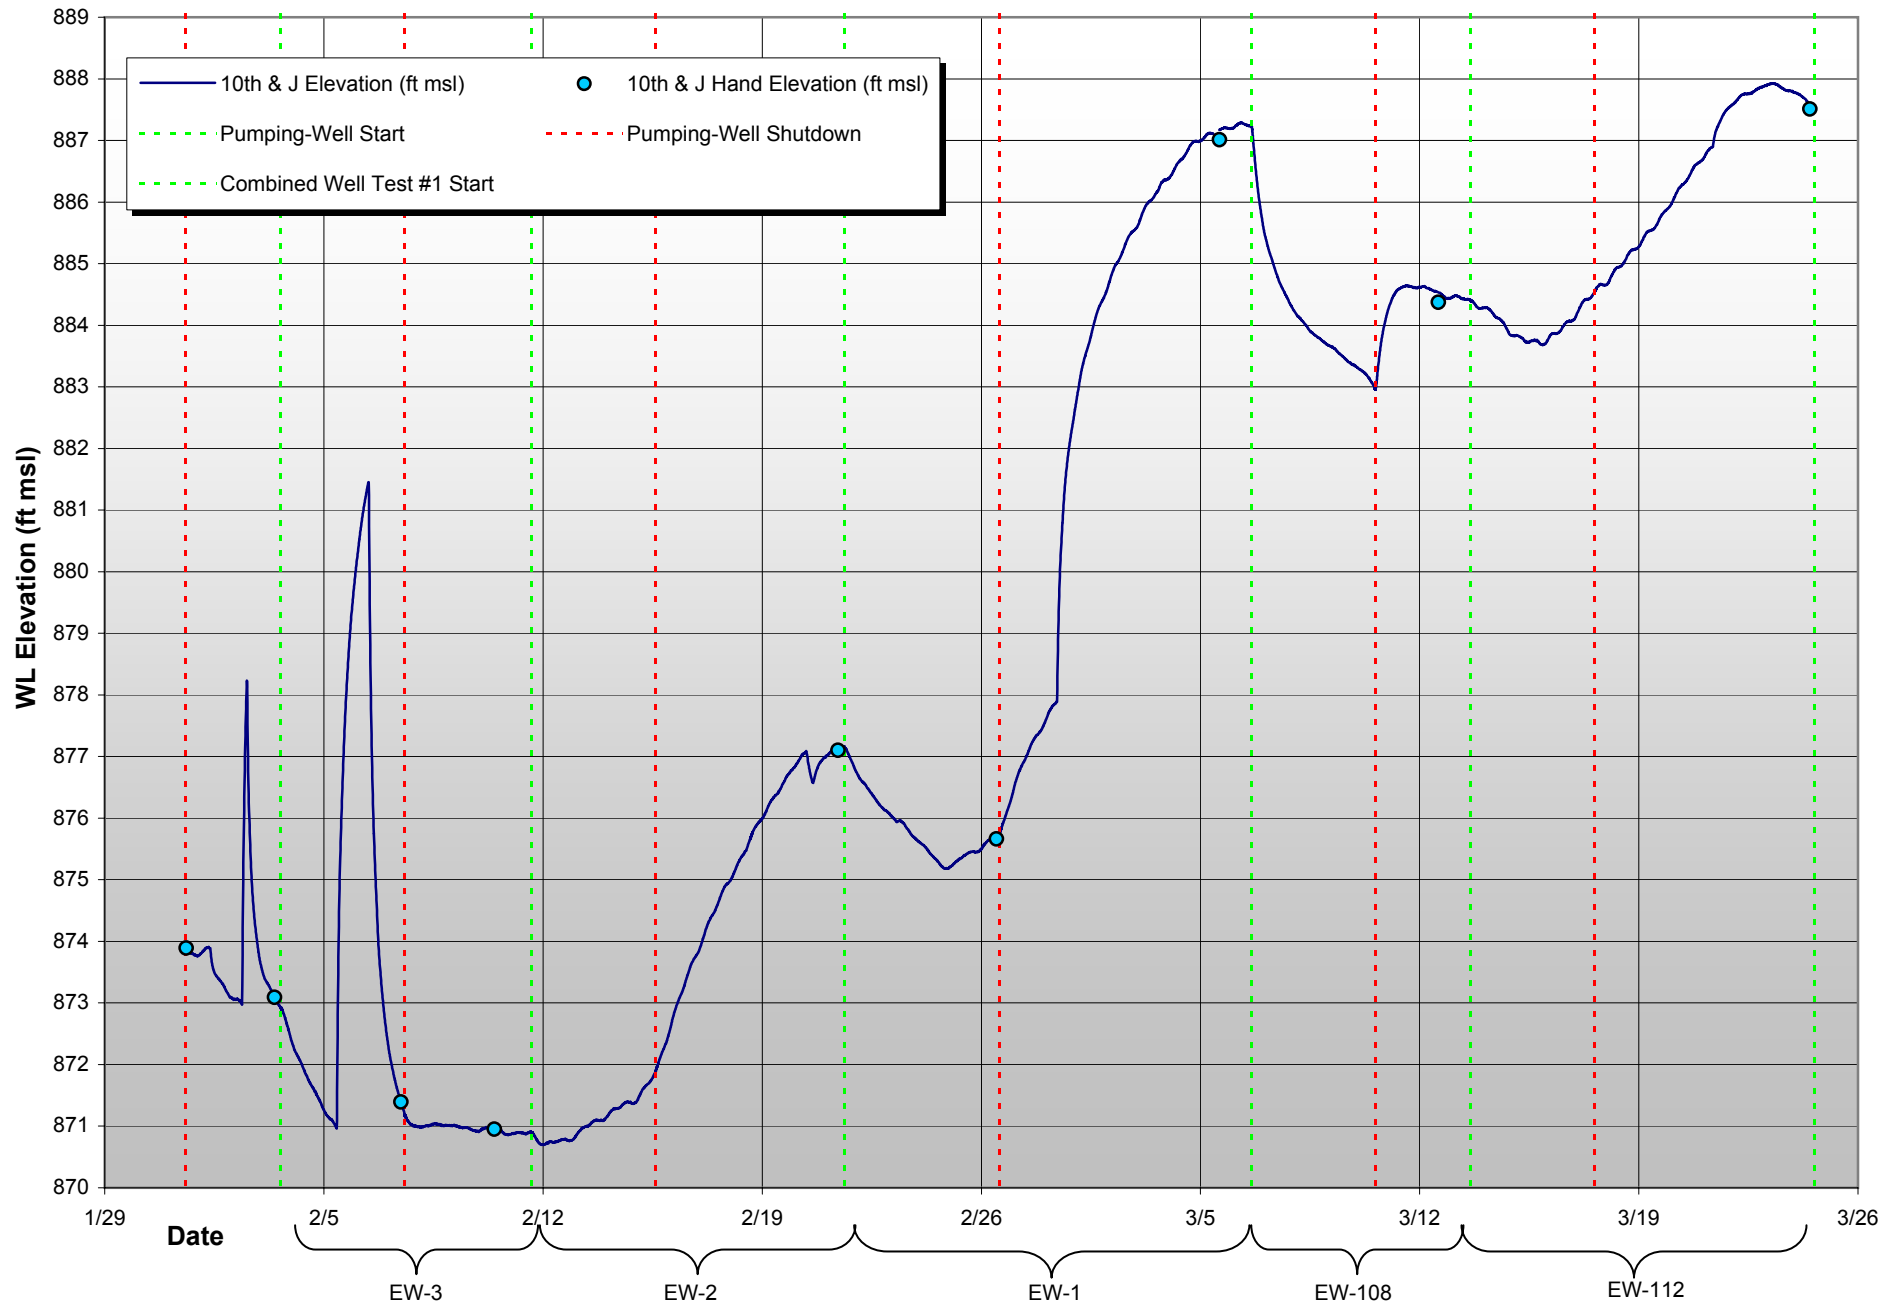
**Figure A-33**  
**Water-Level Elevations in 10th & J Well**
